Manhole Inspection Summary

Manhole # S71G1_002MH

Location Address: **Baltimore Ave.**

Cross Street: **Central Ave.**

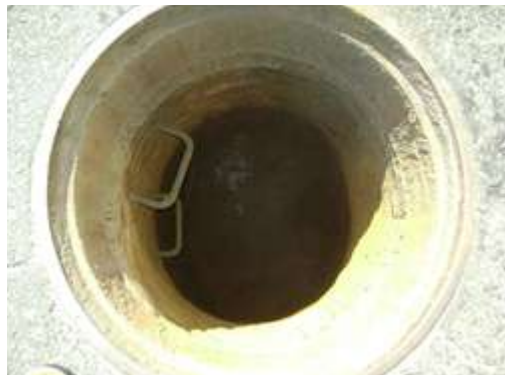
Top View

Condition: ☐ Sound ☐ Cracked ☐ Root Intrusion ☐ Deteriorated ☐ Leaks ☒ **Debris**

Count: **5** Missing: **0** ☒ **Corroded**

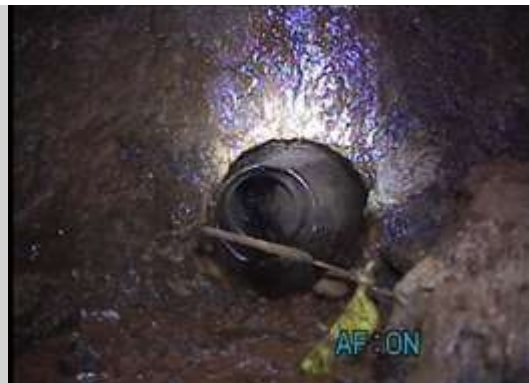
12 O'Clock Outflow

8 in. Circular Gravity Sewer
Pipe Out @ 12 O'Clock

Deposits: ☐ None ☐ Mud ☒ **Gravy** ☐ Debris ☐ Grease

Silt Depth: **0.25** (in.) Deposits Extent: **Light**

Infiltration: **None** Pipe Seal Cond: **Sound**
